Manhole Inspection Summary

Manhole # S35K__024MH

Insp Date: **9/23/08 10:55 AM**

Location Address: **25 andrew place**

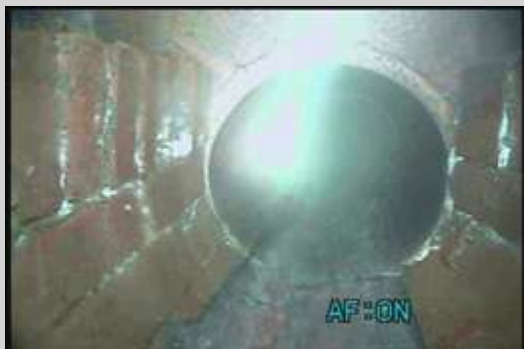
6 O'Clock Inflow

10 in. Circular Gravity Sewer
Pipe In @ 6 O'Clock

Invert Depth: 11.00 (ft.) Flow Characteristics: **Fast**

Infiltration: **None** Pipe Seal Cond: **Unknown**

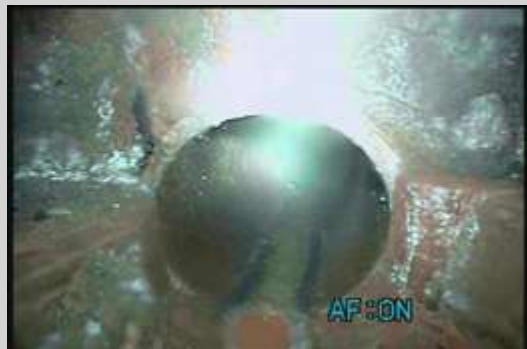
9 O'Clock Inflow

8 in. Circular Gravity Sewer

Pipe In @ 9 O'Clock

Infiltration: **None** Pipe Seal Cond: **Unknown**
